## KLEHOMERIE | Technical Asset Audit (v1.2)

Feb12,2026 / ArnaudZerdab

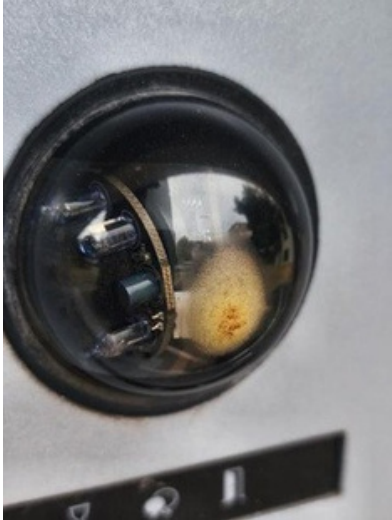
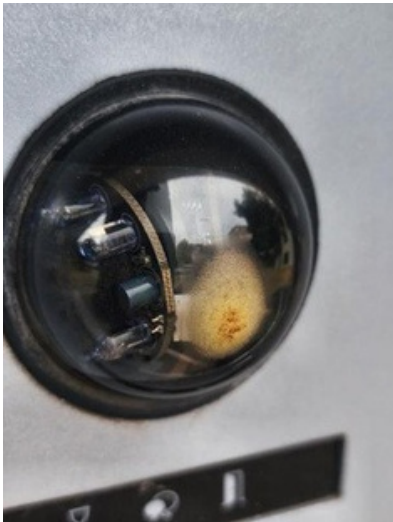
Photo 1

### B-02: Does the Intercom panel look new/functional ?

The camera shutter is burnt

Critical Failure

| <b>B-02: Does the Intercom panel look new/functional ?</b><br>The camera shutter is burnt | | Critical Failure |

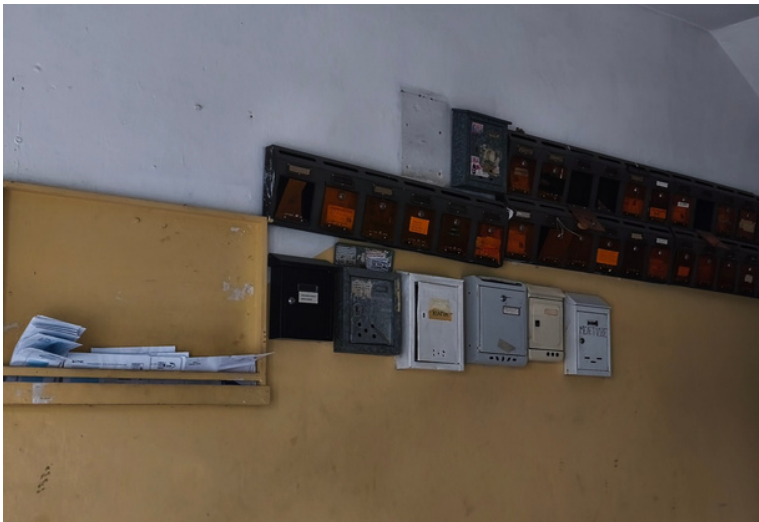
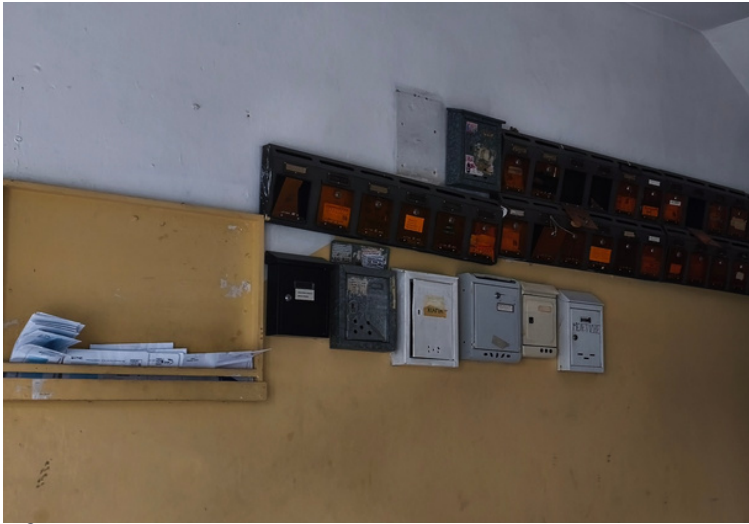
Photo 2

### B-03: Are mailboxes overflowing with junk mail?

Old open mailboxes

| <b>B-03: Are mailboxes overflowing with junk mail?</b><br>Old open mailboxes | | Yes |

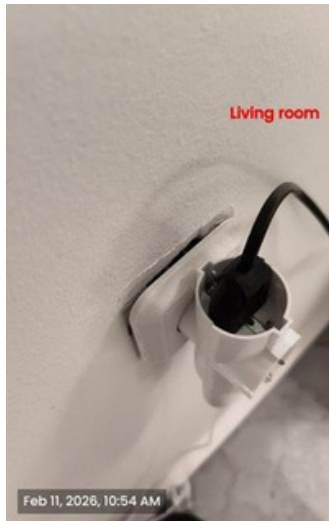
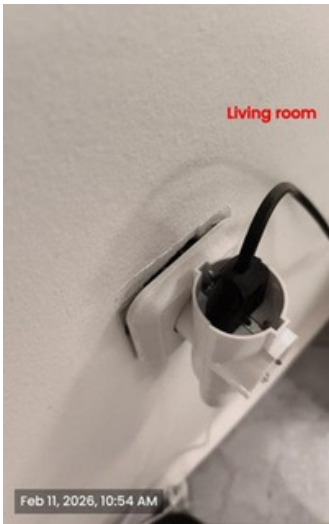
Photo 3

### E-04: Power Sockets (Phase/Earth Loop Test)

Power socket off in living room

Critical Failure

| LOT 01: ELECTRICAL SYSTEMS | | 4 flagged, 5 / 9 (55.56%) |
|---|--|---|
| E-04: Power Sockets (Phase/Earth Loop Test) | | Critical Failure |
| Power socket off in living room | | |

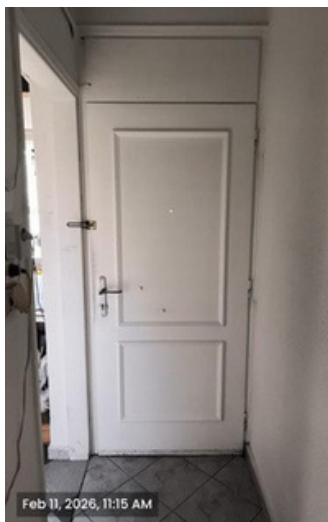
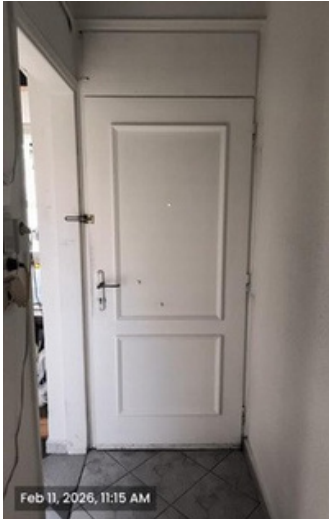
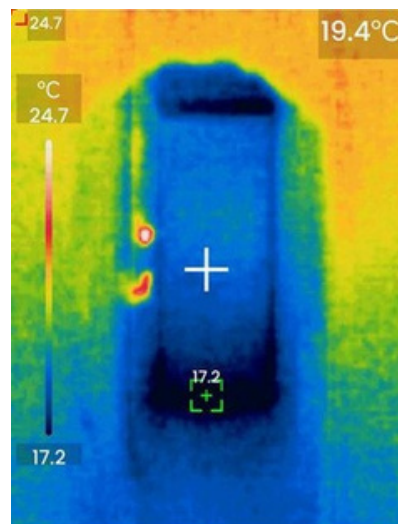
Photo 8

**M-01: Armored Entrance Door (3-Point Lock)**

Critical Failure

Security Risk: Non-armored wooden door (Single-point lock). Energy Risk: Significant thermal bridging detected.

M-01: Armored Entrance Door (3-Point Lock)

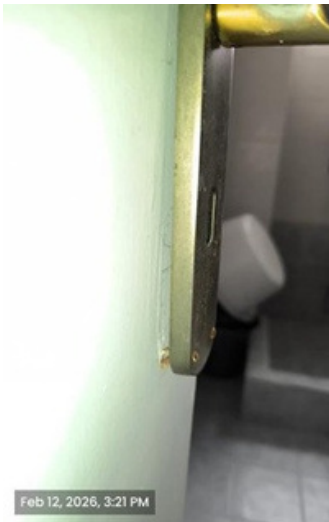
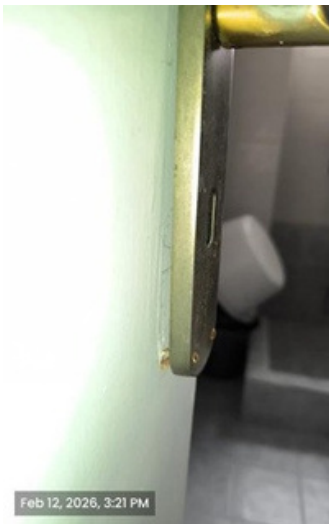
Photo 10

**M-05: Interior Doors (Handles & Hinges)**

Critical Failure

ActionRequired:Replacealldoorhandles(Corrosion/Mechanical failure)

Action Required: Replace all door handles (Corrosion/Mechanical failure)
